Watershed Science Institute Technical Report

Assessing Conditions of Riparian- Wetland Corridors at the Areawide Level

Using Proper Functioning Condition (PFC) methodology -- an interdisciplinary assessment tool

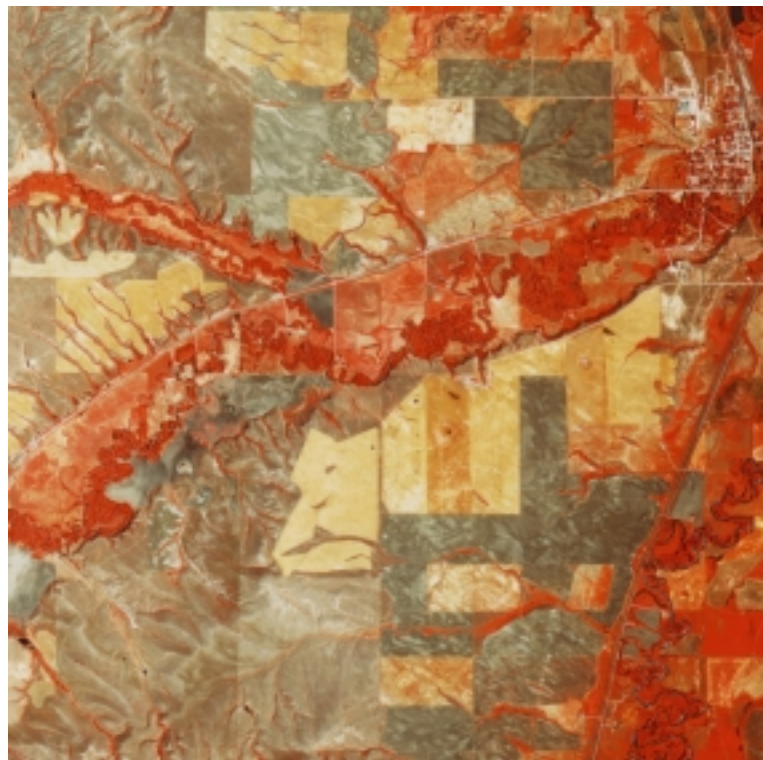
Figure 1. Color infrared photograph of Lodge Grass Creek which flows from the lower left of photo towards Lodge Grass, Montana in the upper right (Crow Indian Reservation). Various types of aerial photography and maps are available from local sources and through the U.S. Geological Survey. USGS may be contacted at 1-888-ASK-USGS or at their web URL: <http://mapping.usgs.gov/www/products/status.html>

materials. (Photos from different years are helpful when making trend determinations.) CIR photos allow interpreters to detect subtle differences in vegetation due to the spectral reflectance of the film (see the image on the front cover).

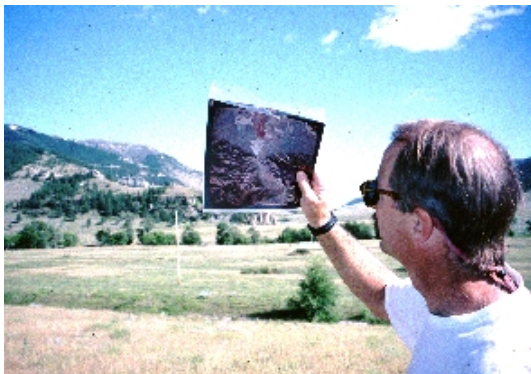
Figure 3. A color-infrared film positive of a watershed on the Crow Indian Reservation, Montana. Aerial photography allows large areas to be viewed and interpreted quickly.

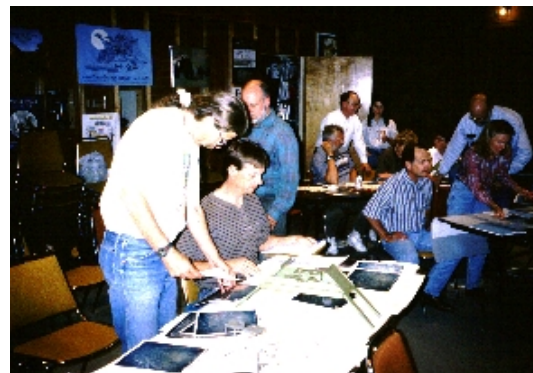
Figure 4. A mirror type stereoscope with at least 4X magnification capability is recommended. A 10-20X monocular hand lens or magnifier also works well for viewing a specific area on an aerial photo.

Equipment needs will vary depending upon type of photo (CIR transparency or paper) and photo scale. A mirror type stereoscope with at least 4X magnification capability is recommended. Magnifications of 10X-20X offer more magnification but reduce the field of view. A monocular hand lens or magnifier also works well for viewing a specific area on an aerial photo. A light table is mandatory when using film transparencies and, when paper prints are used, sharpens images by backlighting. Mylar overlays on topographic maps or photos may be used for recording reach data as it is assessed.

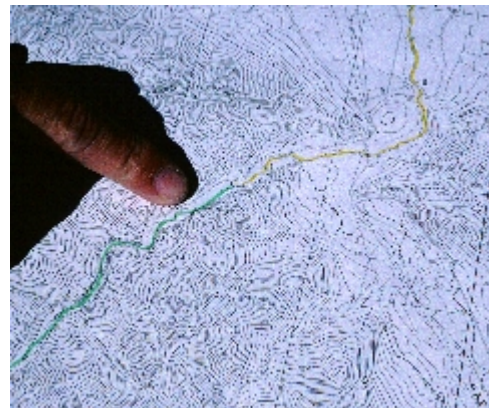
Figure 5. Reach breaks were identified on USGS quadrangle maps for Pryor Creek, Crow Indian Reservation, Montana. During the interpretation phase, the breaks were modified if needed and ratings marked in green (PFC) and yellow (FAR).

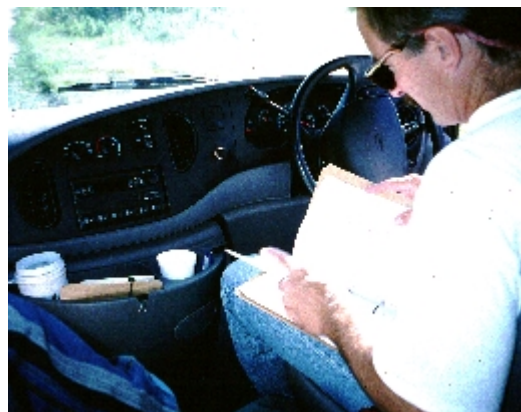
Figure 6. Ground-truthing or field verification should be completed on about 25 percent of the reaches. Changes need to be made on applicable base maps or mylars and in data summaries.

- Ground-truthing or field verification should be completed on about 25 percent of the reaches.
- Global Positioning System or GPS units can facilitate identification of reach breaks, areas of concern and other features during ground-truthing.

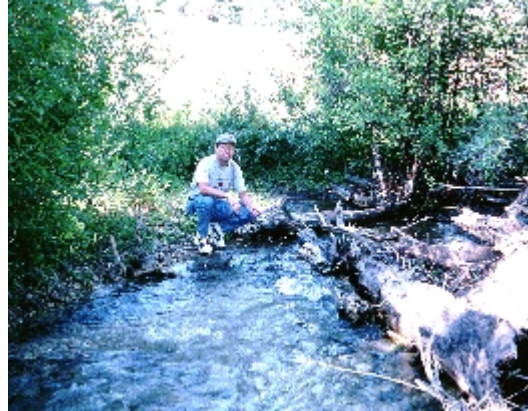
Figure 7. In some cases, channel characteristics are difficult to interpret depending greatly on the scale and quality of aerial photography. On-the-ground reconnaissance of an area before the photo interpretation phase can greatly improve an interpreter's skill level.

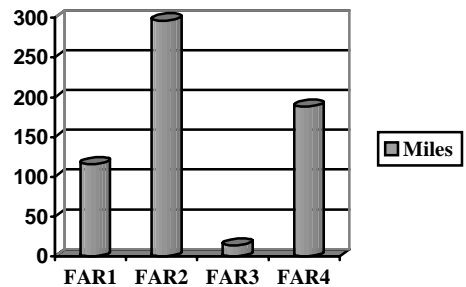
Figure 12. FAR rated reaches subdivided by land use/impacts.

Because of the large number of miles in the FAR condition (and the likely priority FAR reaches would be given later during planning), the aerial photographic PFC methodology was expanded to identify adjacent, predominant sub-watershed land uses and impacts. This modification allowed the ID team to recognize probable cause-effect relationships between watershed condition and reach condition. Non-functional reaches were not analyzed in this manner because of their relatively low mileage. For the Crow Reservation, the observed land uses/impacts (see Figure 12) were denoted by four FAR sub-classes:

- FAR1 - reaches affected by grazing use
- FAR2 - reaches affected by cropland use
- FAR3 - reaches affected by both grazing and cropland use.
- FAR4 - reaches affected by channel straightening, structures, road encroachment, and reaches where the cause of impairment was not apparent

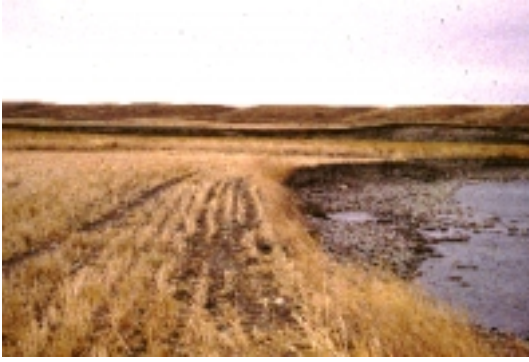
Figure 18. Agricultural cultivation and cropping practices to the stream's edge are a concern on Cut Bank Creek in the Cut Bank Creek Watershed, Montana.

Agricultural cultivation and cropping practices to the edge of stream banks was another concern. Annual crops and hay do not have the rooting depth and strength to protect the stream banks from erosion. Riparian buffers of suitable woody and herbaceous species could alleviate this source of instability. Some form of bank stabilization would be needed for the more severe areas either before or during riparian buffer establishment.
