Watershed Science Institute Technical Report

Assessing Conditions of Riparian- Wetland Corridors at the Areawide Level

Using Proper Functioning Condition (PFC) methodology -- an interdisciplinary assessment tool

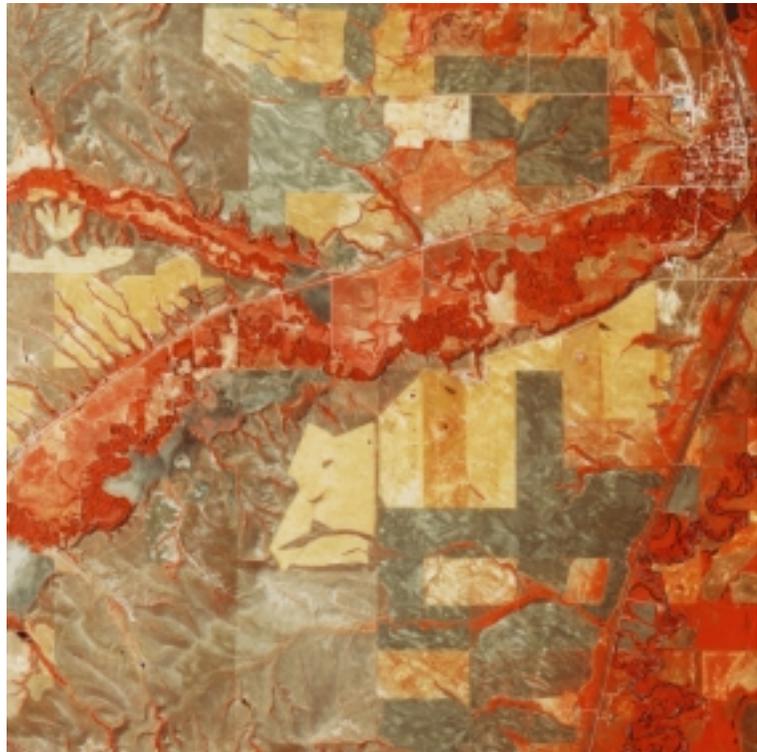
Figure 1. Color infrared photograph of Lodge Grass Creek which flows from the lower left of photo towards Lodge Grass, Montana in the upper right (Crow Indian Reservation). Various types of aerial photography and maps are available from local sources and through the U.S. Geological Survey. USGS may be contacted at 1-888-ASK-USGS or at their web URL: <http://mapping.usgs.gov/www/products/status.html>

materials. (Photos from different years are helpful when making trend determinations.) CIR photos allow interpreters to detect subtle differences in vegetation due to the spectral reflectance of the film (see the image on the front cover).

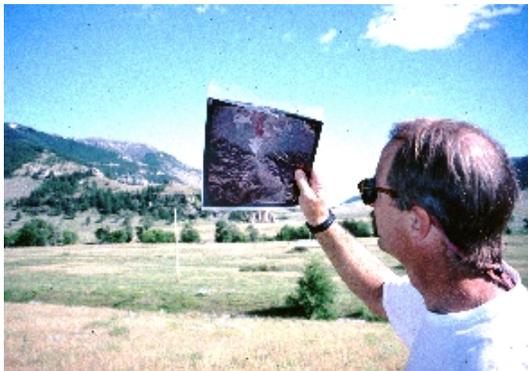
Figure 3. A color-infrared film positive of a watershed on the Crow Indian Reservation, Montana. Aerial photography allows large areas to be viewed and interpreted quickly.

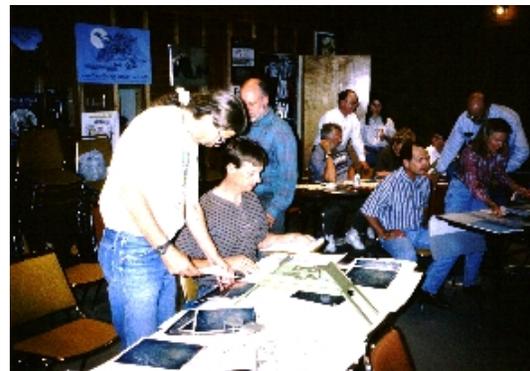
Figure 4. A mirror type stereoscope with at least 4X magnification capability is recommended. A 10-20X monocular hand lens or magnifier also works well for viewing a specific area on an aerial photo.

Equipment needs will vary depending upon type of photo (CIR transparency or paper) and photo scale. A mirror type stereoscope with at least 4X magnification capability is recommended. Magnifications of 10X-20X offer more magnification but reduce the field of view. A monocular hand lens or magnifier also works well for viewing a specific area on an aerial photo. A light table is mandatory when using film transparencies and, when paper prints are used, sharpens images by backlighting. Mylar overlays on topographic maps or photos may be used for recording reach data as it is assessed.

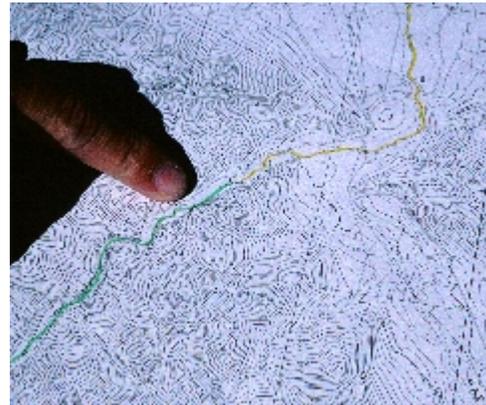
Figure 5. Reach breaks were identified on USGS quadrangle maps for Pryor Creek, Crow Indian Reservation, Montana. During the interpretation phase, the breaks were modified if needed and ratings marked in green (PFC) and yellow (FAR).

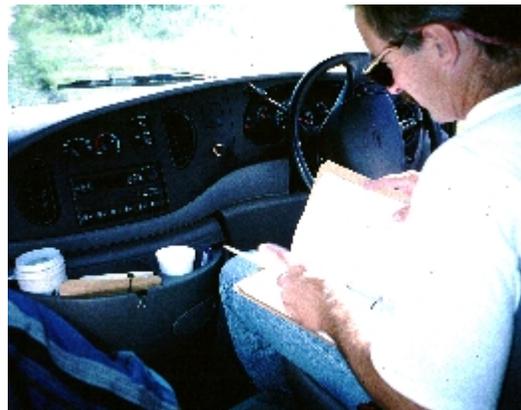
Figure 6. Ground-truthing or field verification should be completed on about 25 percent of the reaches. Changes need to be made on applicable base maps or mylars and in data summaries.

- Ground-truthing or field verification should be completed on about 25 percent of the reaches.
- Global Positioning System or GPS units can facilitate identification of reach breaks, areas of concern and other features during ground-truthing.

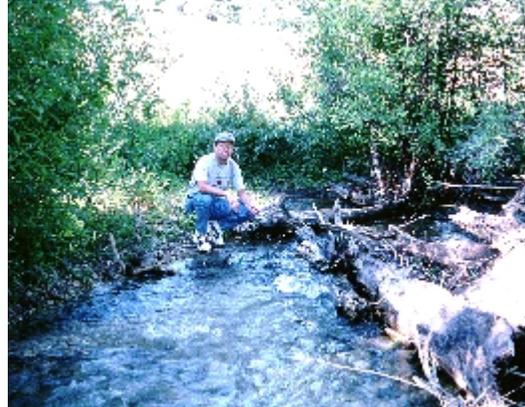
Figure 7. In some cases, channel characteristics are difficult to interpret depending greatly on the scale and quality of aerial photography. On-the-ground reconnaissance of an area before the photo interpretation phase can greatly improve an interpreter's skill level.

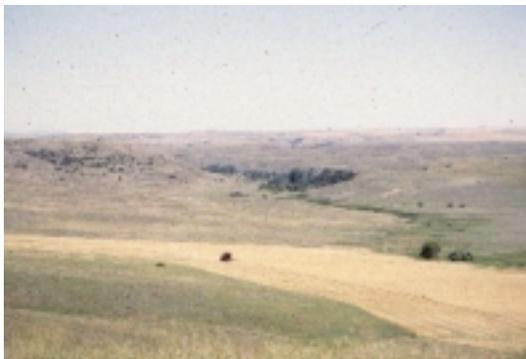
Figure 8. Headwaters of East Buckeye Creek. Dryland agriculture and grazing land with woody draws were common on the Crow Indian Reservation, Montana.

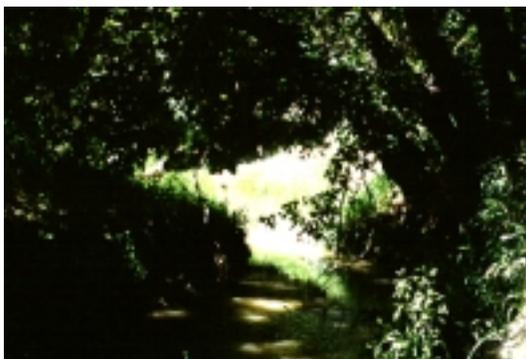
Figure 13. An incised Owl Creek reach rated FAR that appeared to be stabilized on the Crow Indian Reservation, Montana.

Owl Creek and other streams in the southeast portion of the Little Big Horn River Watershed were somewhat puzzling and difficult to rate (see figure 13). These streams had become incised in the past yet appeared to have stabilized without the development of significant flood plains. The team could not assign ratings on these reaches based on the standard PFC checklist alone. Data on channel geometry and hydrology were collected to determine if these reaches had experienced a 25-year frequency flow. Further analysis indicated that since the down-cutting had occurred, these stream reaches had not experienced any 25-year flow events. These reaches were assigned a rating of FAR since the flood plain characteristics appeared inadequate to provide stability through a 25-year flow event. The site-based version of PFC methodology would have also required the collection and analysis of channel geometry and hydrology. In most cases, whether the PFC assessment is remote or site-based,

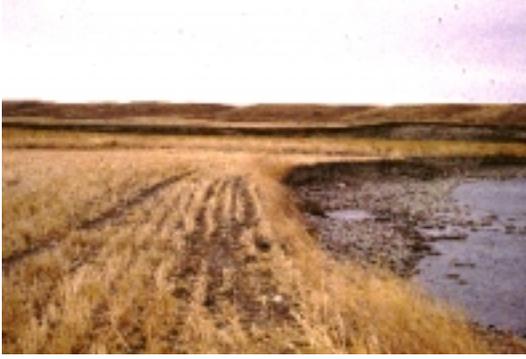
Figure 18. Agricultural cultivation and cropping practices to the stream's edge are a concern on Cut Bank Creek in the Cut Bank Creek Watershed, Montana.

Agricultural cultivation and cropping practices to the edge of stream banks was another concern. Annual crops and hay do not have the rooting depth and strength to protect the stream banks from erosion. Riparian buffers of suitable woody and herbaceous species could alleviate this source of instability. Some form of bank stabilization would be needed for the more severe areas either before or during riparian buffer establishment.
