Natural
Resources
Conservation
Service

Case Summary Report

Applying Geomorphic Principles to Sands and Low Plasticity Silts in the Sugar Creek Watershed Project

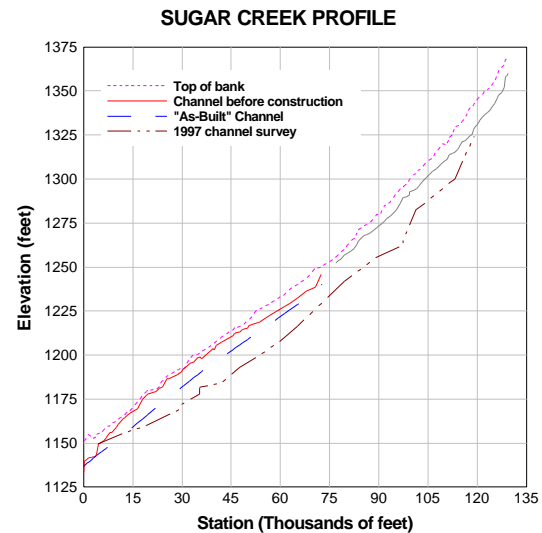
Figure 2. Degradation of Sugar Creek since 1966. Note that the original survey underestimated the actual stream length as the thalweg was not strictly followed. (The thalweg is the line of maximum depth in the stream).

Initially, designers felt so much sediment was moving through the system that extreme operation and maintenance measures would be necessary to keep the constructed channel open. Actually, the response of the channel was exactly the opposite. A process of degradation began almost immediately and has continued ever since. Over the past thirty years, the channel has incised over 23 feet in some locations with depths of 15 to 20 feet very common (see Figure 2). Entrenchment of the

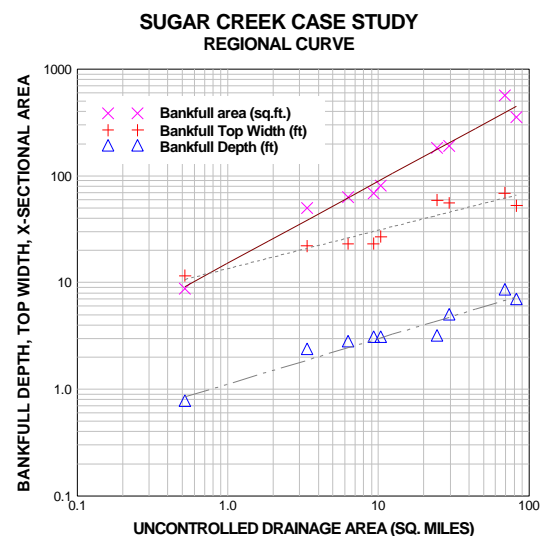
Figure 4. Regional Curve developed for the Sugar Creek study.

The regional curve (see Figure 4) is essential in developing a geomorphic solution in highly disturbed systems, particularly in the absence of reference reaches. It becomes the design blueprint for the properly functioning stream by defining important stream characteristics including bankfull area, bankfull width, and mean depth.

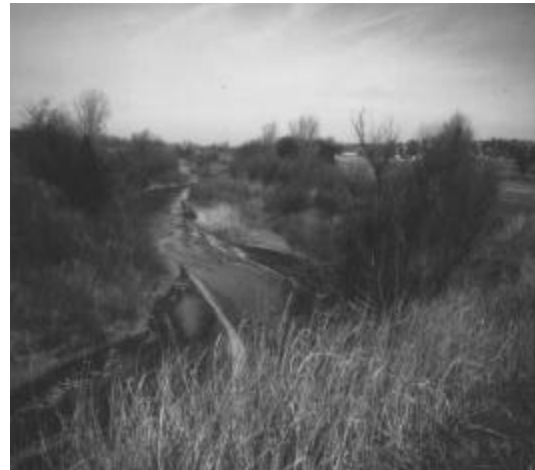
Figure 7. A C5 stream type is beginning to develop in this reach.

Trends in changing sinuosity were also noted. In 1937, a minimally impacted reach had a calculated sinuosity of 1.4. The same reach in 1995 showed the effects of extensive straightening with a sinuosity slightly less than 1.1. The objective of restoration for this reach should be to move the sinuosity back toward the more "natural" 1.4. If physical constraints prevent this, an alternative is to develop a stream type which is stable at a lower sinuosity. A well defined C5 channel is also developing between stations 419+69 and 477+32 in spite of rigid boundaries imposed by the incised channel (see Figure 7). Because a sufficient flood plain does not exist in this area, it is anticipated that larger events would destroy the C5 channel causing the process to begin anew.

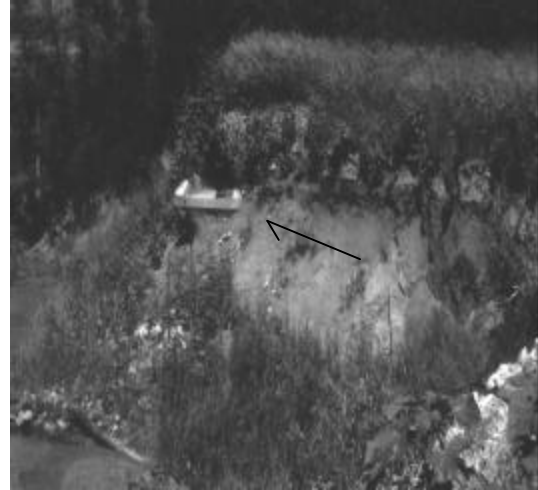
Figure 8. Note location of concrete pad for road culvert relative to current stream location and lack of vegetation in the midbank region.

Soil moisture decreases with the height of the bank so there is likely insufficient moisture in mid-bank for vegetative establishment. Moisture is actually more plentiful in the upper 4 to 5 feet of the bank because the original soil profile has remained relatively intact. Vegetation could be established in this zone. However, the ability to stabilize the banks in the near term is extremely doubtful since roots would have to extend down 20 to 30 feet to be effective. Given the instability of these banks, even the most vigorous roots could not reach these depths before the plants were severely undercut and lost (see Figure 8). Some type of slope and bank height modification consistent with the designed plan form may be necessary to facilitate vegetation over the entire bank.
