# WATERSHED SCIENCE INSTITUTE WATER MANAGEMENT CENTER NRCS STATE OFFICE - OKLAHOMA

## Case Summary Report

### Applying Geomorphic Principles to Sands and Low Plasticity Silts in the Sugar Creek Watershed Project

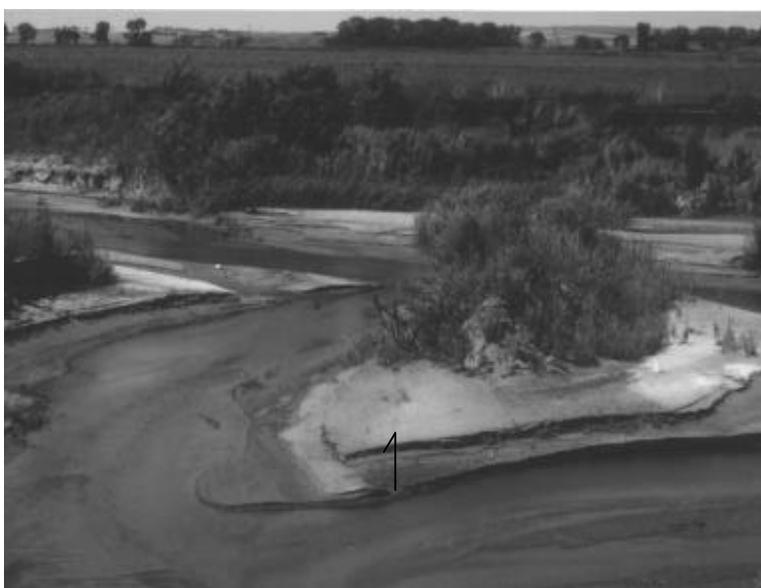
Figure 1. Sugar Creek shown 3 miles north of Gracemont illustrates extensive channel widening and readjustment. Remnants of jacks on the left side of island mark the edge of stream at some time in the past.

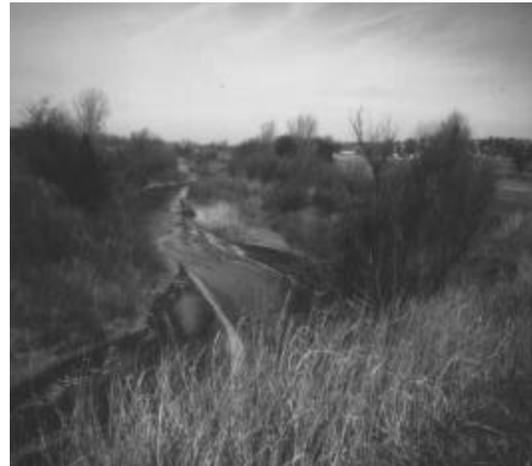
Figure 7. A C5 stream type is beginning to develop in this reach.

Trends in changing sinuosity were also noted. In 1937, a minimally impacted reach had a calculated sinuosity of 1.4. The same reach in 1995 showed the effects of extensive straightening with a sinuosity slightly less than 1.1. The objective of restoration for this reach should be to move the sinuosity back toward the more "natural" 1.4. If physical constraints prevent this, an alternative is to develop a stream type which is stable at a lower sinuosity. A well defined C5 channel is also developing between stations 419+69 and 477+32 in spite of rigid boundaries imposed by the incised channel (see Figure 7). Because a sufficient flood plain does not exist in this area, it is anticipated that larger events would destroy the C5 channel causing the process to begin anew.

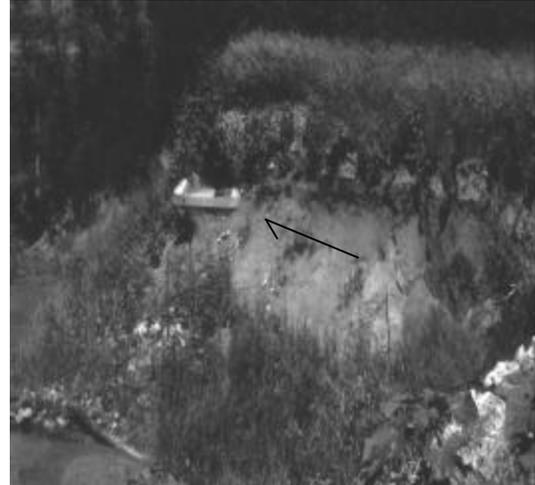
Figure 8. Note location of concrete pad for road culvert relative to current stream location and lack of vegetation in the midbank region.

Soil moisture decreases with the height of the bank so there is likely insufficient moisture in mid-bank for vegetative establishment. Moisture is actually more plentiful in the upper 4 to 5 feet of the bank because the original soil profile has remained relatively intact. Vegetation could be established in this zone. However, the ability to stabilize the banks in the near term is extremely doubtful since roots would have to extend down 20 to 30 feet to be effective. Given the instability of these banks, even the most vigorous roots could not reach these depths before the plants were severely undercut and lost (see Figure 8). Some type of slope and bank height modification consistent with the designed plan form may be necessary to facilitate vegetation over the entire bank.
